Assessment of Dam Safety

Coal Combustion Surface Impoundments (Task 3)

Final Report

Duke Energy
Riverbend Steam Station
Mt. Holly, North Carolina

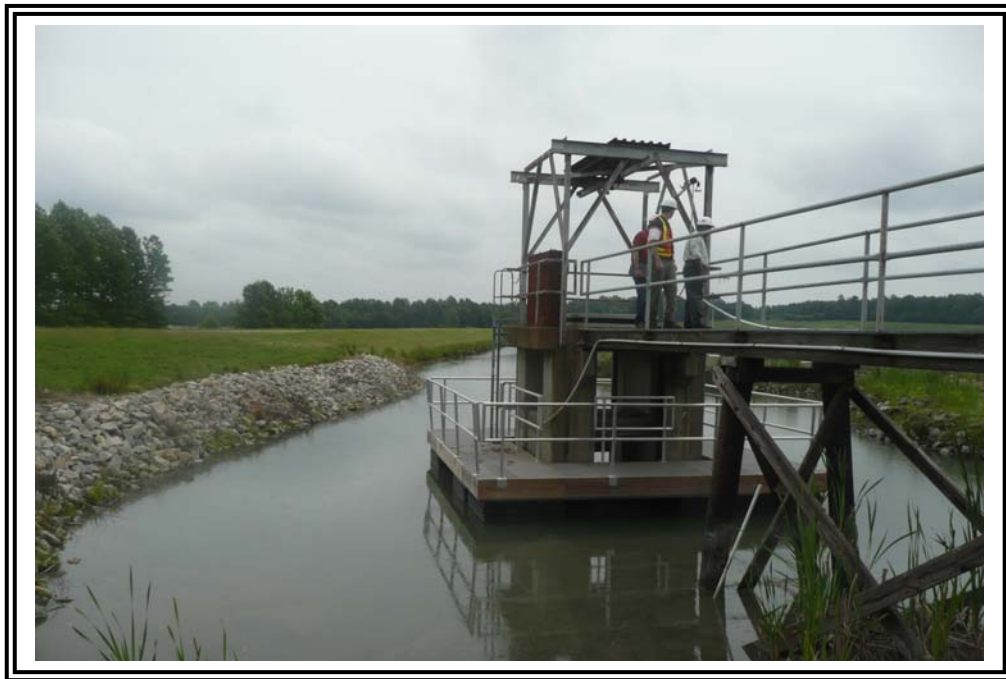
Primary pond outlet tower at north corner of the pond.

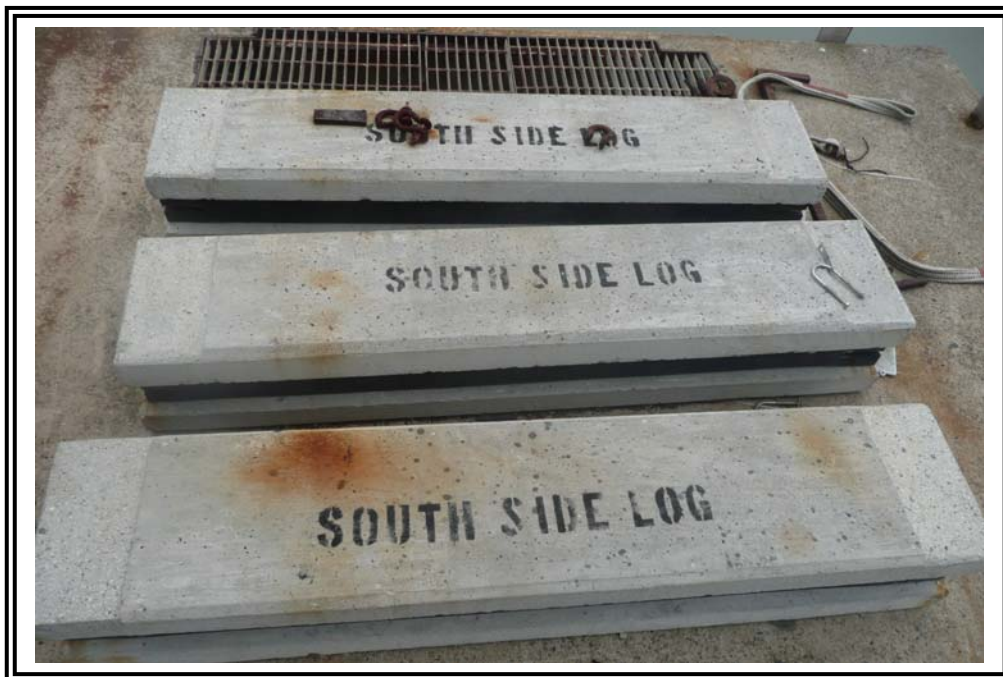
22

Concrete stop logs used to regulate water level in the primary pond.

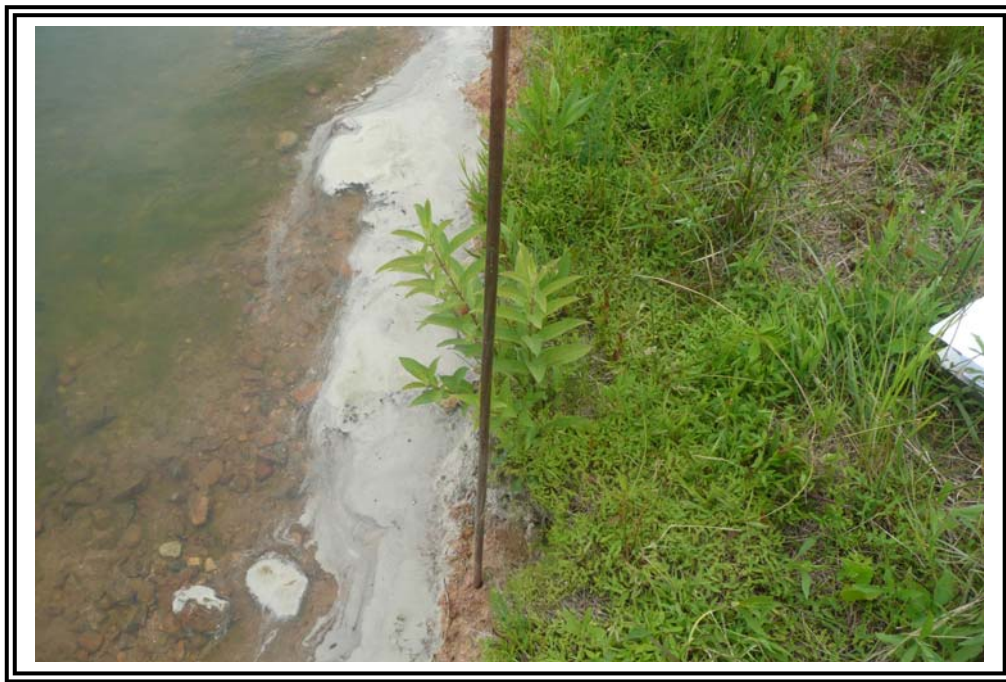
Along the upstream slope, an inboard ash diverter dike was constructed during previous dredging operations and left in place to create a dewatering channel for future dredging operations. Photos 25 through 27 show this dewatering channel. A breach in this diverter dike, as shown in Photo 31, is filled in during dredging operations, and then rebreached to allow normal operating flows to reach the outlet control structure for the primary ash pond. Slight beach erosion was noted at the water line of the upstream slope.

Upstream slope intermediate dike beach erosion. Floating material is composed of cenospheres.

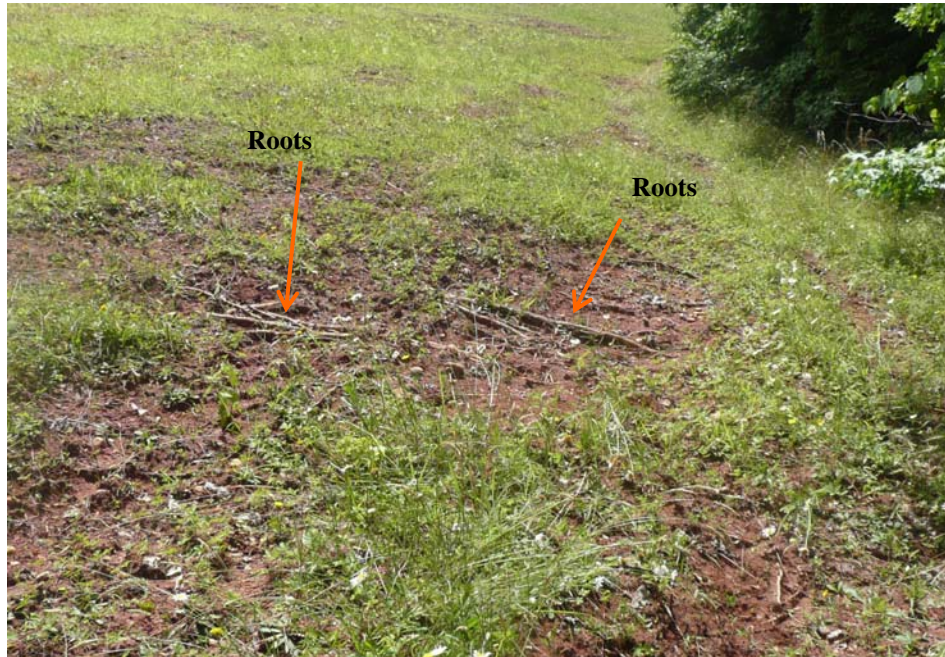
47

The downstream slope was reasonably uniform and predominantly covered with appropriate grass vegetation although areas of sparse grass were noted in isolated areas, some of which appeared related to mower wheels sliding on the slope. Photos 45 through 52 and 57 through 59 show the condition of the downstream slope. Near the tree line at the northwest edge of the high embankment, roots were noted on the ground surface. It appeared these roots were growing from trees located immediately beyond the toe.

Close up of root growth shown in Photo 46.

Tree roots were observed at the slope surface near the northwest end of the secondary dike. These tree roots appear to be from trees growing beyond the toe of the dam. CHA recommends that Duke Energy, under the direction of a professional engineer, remove trees from beyond the toe of the dam, and remove large root masses in the embankment toe.

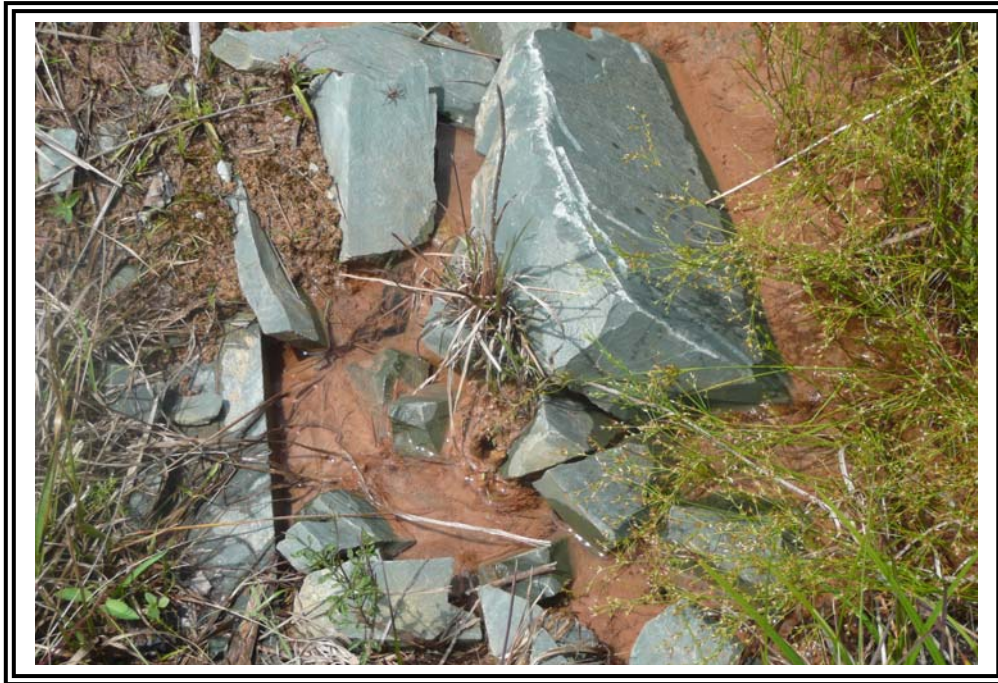
55

Seepage, as shown in Photos 54 and 55, was observed from the toe drain between redacted northwest of a rip rapped swale extending beyond the toe of the dam (see photo 56).

Flowing water was observed in these seepage areas, and the type of vegetation at the toe was indicative of perennially wet conditions. The observed flow was clear.

Seepage at the toe of the secondary dike about 300 feet from piezometer row. Water is clear.

As discussed in Section 2.3.1, flowing seepage was observed at the toe of the secondary dike. Duke Energy was aware of this seepage and makes observations of this area during their routine inspections. CHA recommends a collection trench or pipe and monitoring weir be installed in this area to facilitate quantifiable volume measurements and sample collection. Quantifiable measurements will allow Duke Energy and outside consultants to see changes if they occur.. Any changes would need to be addressed.

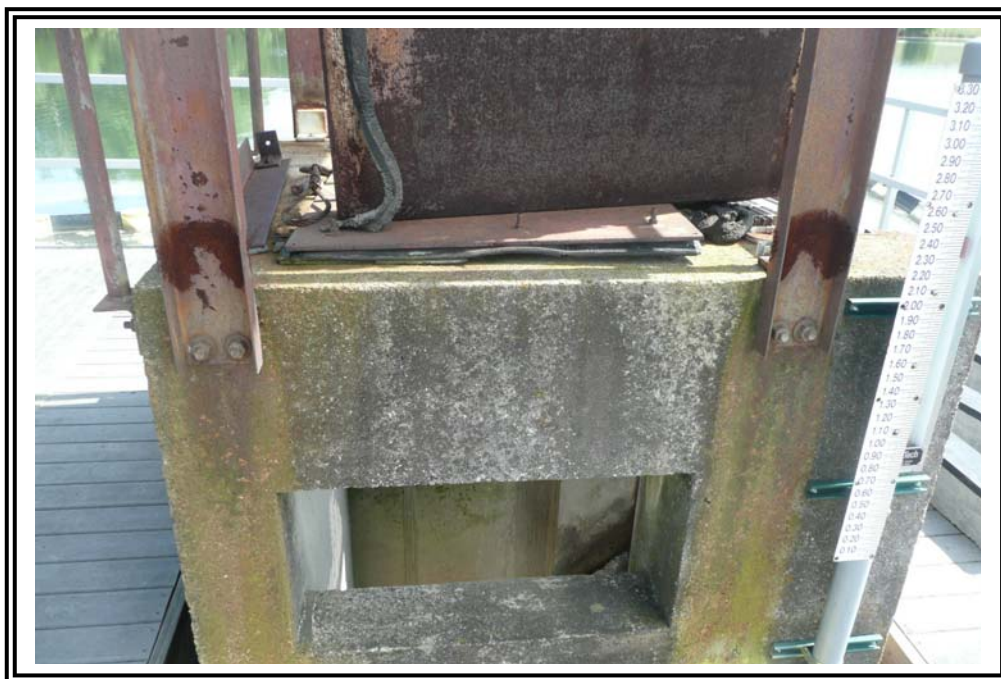
62

Intake tower in secondary pond.

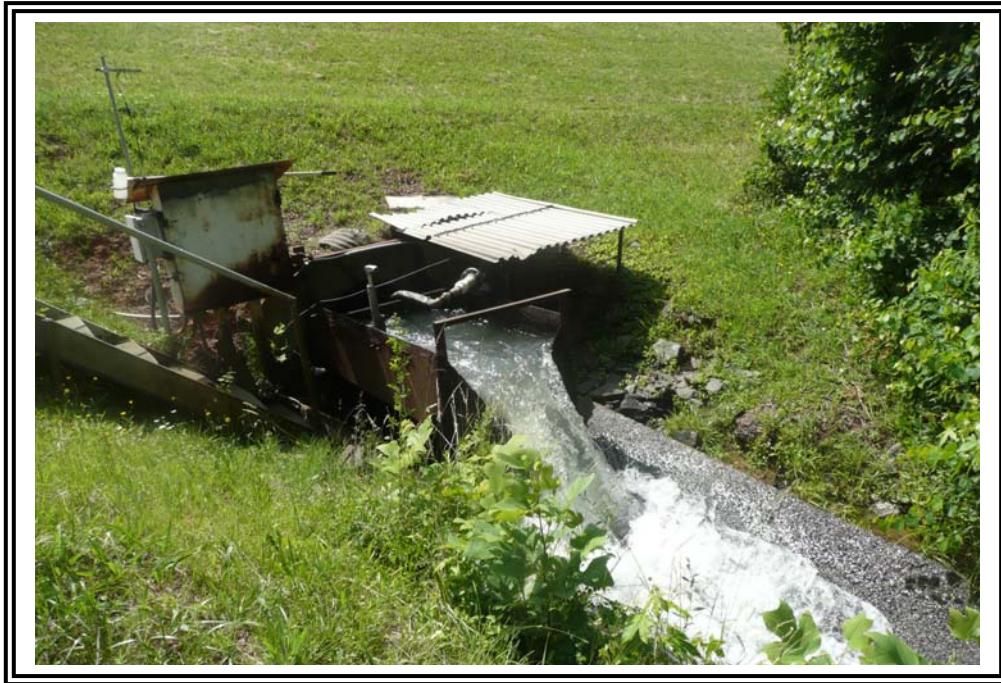
63

Outlet structure at toe of secondary dike, looking upstream to the south-southwest (towards secondary cell).
